Excavator Thrust Plate Wear Issues and How to Alleviate them with Enhanced Performance Parts

1.0 Common Issue with Bucket-Stick Arrangements in Excavators

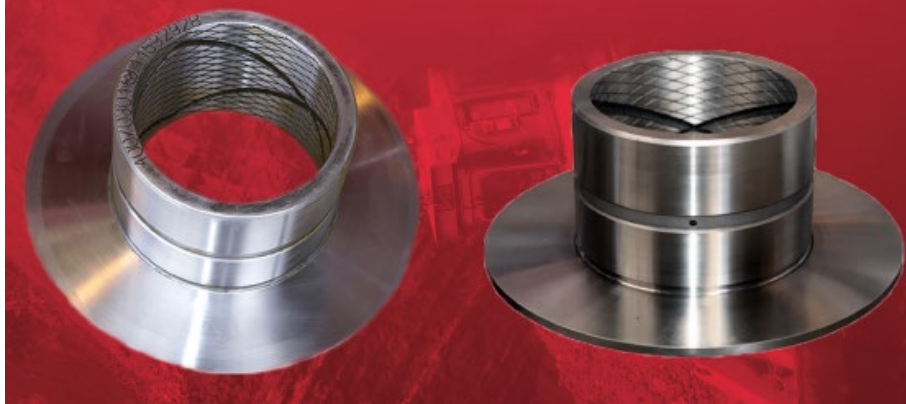
The Top Hat Bush combines a thrust plate and bush together as a single component and is manufactured from a single piece of material for integral strength and durability. It shares the same material and gas carburization heat treatment processes as the standalone bush, which gives the entire component a 2 mm case depth at 58-63HRC, resulting in the stick-to-bucket tolerance remaining at OEM specification for longer. The EP Top Hat Bush has grease grooves and cross hatching within the bore for superior lubrication (see Figure 1).

Figure 1. Grease grooves and a cross hatching within the pore of the Top Hat Bush enhanced performance part.
